Project No.  
**6964.002.025**

June 15, 2026

Subject: Siena Hill Development  
Oakland, California

## **OAKLAND AREA GEOLOGIC HAZARD ABATEMENT DISTRICT MONITORING – SPRING 2026**

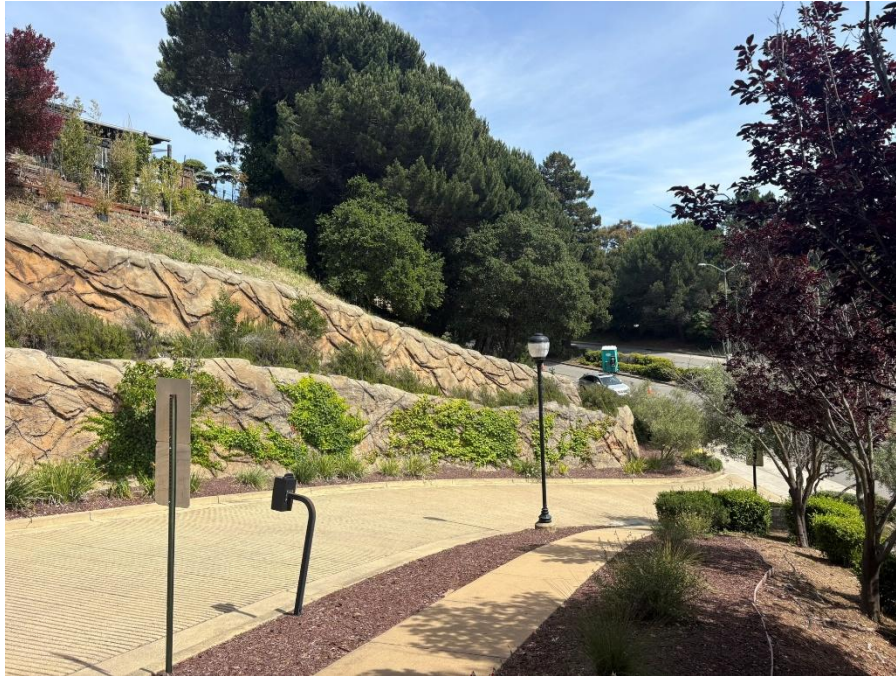
The irrigation improvements above Lot 1 (79 Siena Drive), as noted in previous reports, are not specifically a part of our GHAD monitoring and maintenance overview. However, we will continue to monitor potential effects these improvements might have on the slope and walls in Lot 1 that are a part of our GHAD monitoring. During our recent monitoring event, we did not observe erosion or slope instability in the area of the irrigated landscape plantings (Site Condition A, Figure 1, Photo 1). We will continue to monitor the bare soil, which can have a higher risk of erosion. In addition, excessive watering or an irrigation leak could lead to erosion or shallow instability on the slope. As of the recent monitoring event, there are no indications of excess run-off or slope instability.

Since August 2017, we observed that backfill behind the retaining wall in Lot 1 was approximately 1 foot lower than the top of the retaining wall. During this monitoring event, this condition remained unchanged. The GHAD has determined that the lower grade elevation behind the wall effectively serves as a catchment area for potential surface erosion that could occur in the future from the slope area mentioned above (Site Condition A).

**PHOTO 1: Site Condition A: Irrigated Plants and Improvements  
Extending from 4312 Rilea Way into Lot 1 (79 Siena Drive)**

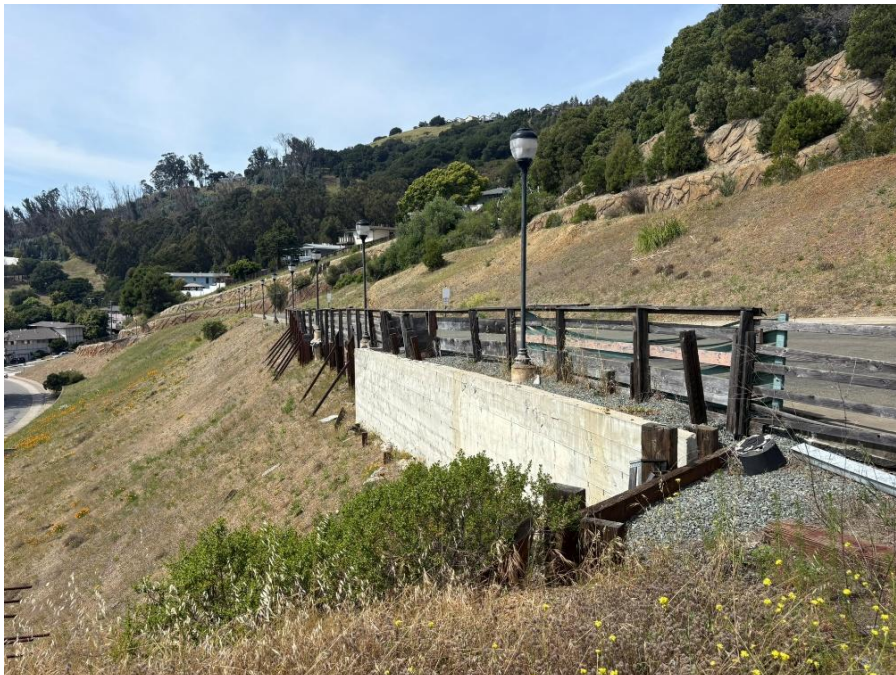
A temporary wooden retaining wall is located northwest of the accepted lots along Siena Drive. Although the temporary retaining wall is not located on a GHAD-accepted parcel, we reported our concerns about this retaining wall as early as 2015 due to its poor condition. The temporary retaining wall supports a portion of Siena Drive, the adjacent sidewalk, and possible utilities within the roadway. During our Fall 2019 monitoring event, we observed that a concrete retaining wall was constructed to replace the southeastern segment of the wooden retaining wall. The replaced segment of the retaining wall appears to be performing well as of our most recent monitoring; however, voids were observed in the backfill of the concrete retaining wall and the wall

construction was left incomplete with exposed rebar reinforcement (Site Condition B, Figure 1, Photo 2). The GHAD will continue to monitor the temporary retaining wall conditions during future monitoring events.

**PHOTO 2: Site Condition B: Condition of Concrete Retaining Wall**

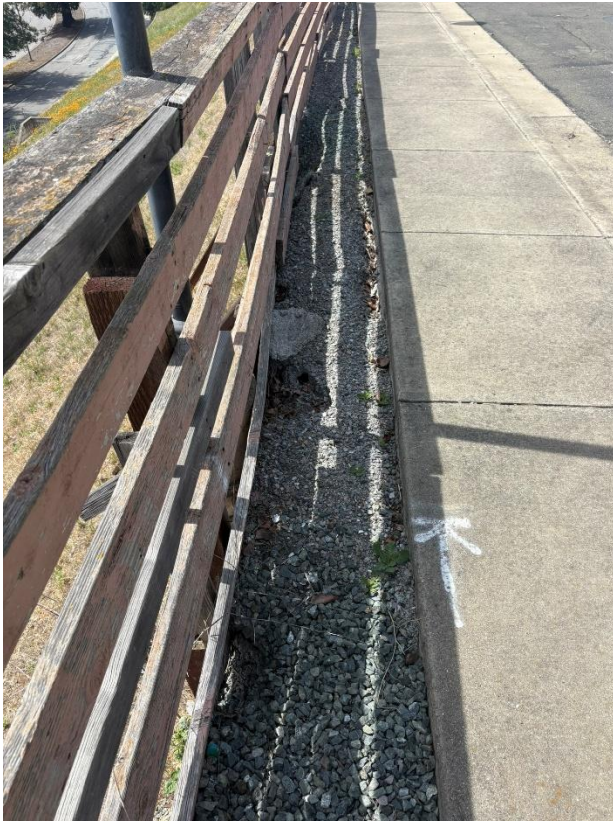
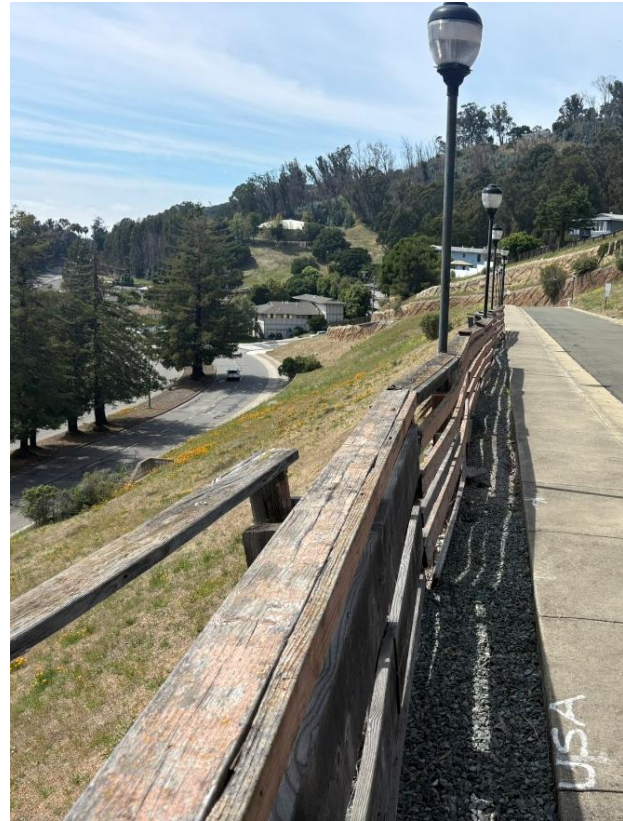
During our Spring 2020 monitoring event, we noted that tension cracks had formed behind the remaining segment of the temporary wooden retaining wall adjacent to Siena Drive. The wooden retaining wall was leaning moderately in the downhill direction. In the Fall 2020 monitoring event, we observed that the section of the retaining wall that was leaning was reinforced with wooden buttresses. The tension cracks adjacent to the sidewalk were backfilled and the gravel was refreshed. During our Fall 2025 and Spring 2026 visits, we observed some of these voids increasing behind the wall (Site Condition C, Figure 1, Photos 3 and 4). These voids should be backfilled, and we will continue to monitor the voids and the retaining walls for areas that could potentially impact GHAD-maintained facilities.

**PHOTOS 3 and 4: Site Condition C: Voids in the Gravel Backfill (left)  
and Current State of Wooden Retaining wall (Right)**

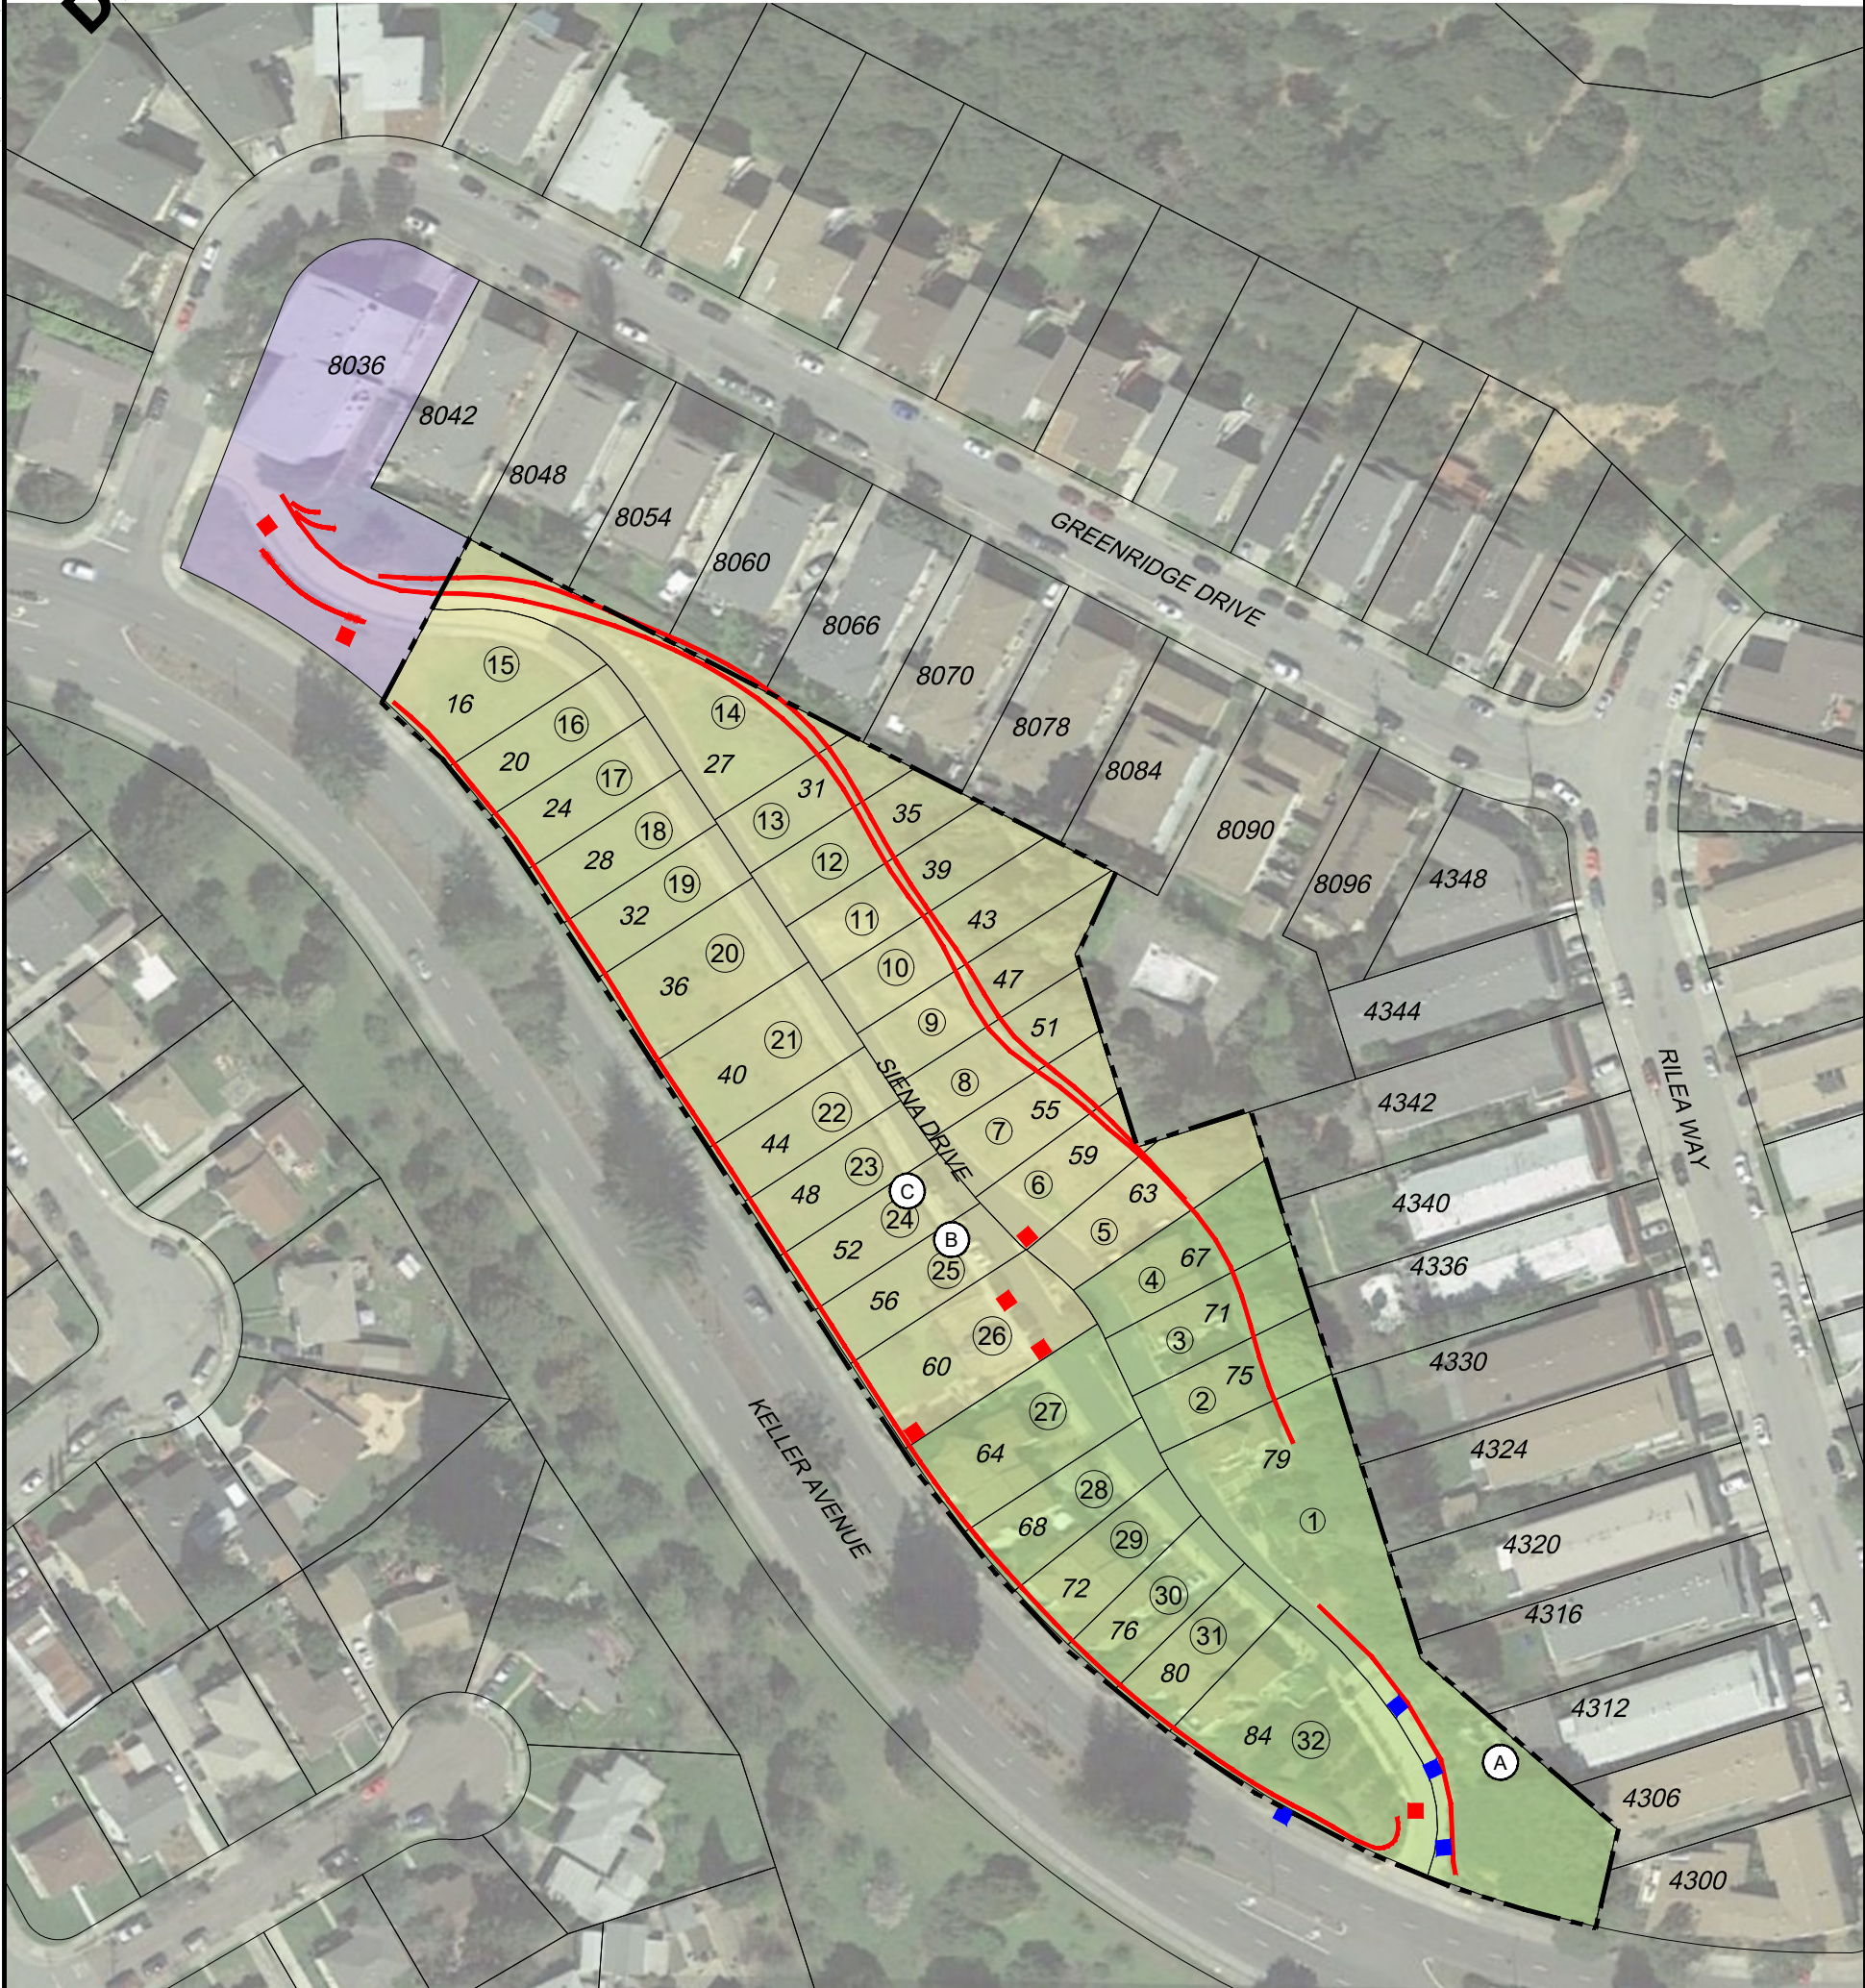
**FIGURE 1**

As shown in Figure 1, attached, the GHAD accepted and provides monitoring and maintenance responsibilities for 10 parcels with completed residences. At this time, the GHAD has not been offered nor accepted monitoring or maintenance responsibilities on the remaining 22 residential parcels and the easement area.
